First Five-Year CERCLA Review of Seven Pearl Harbor Naval Complex National Priorities List Sites

JOINT BASE PEARL HARBOR-HICKAM, OAHU, HAWAII

September 2014

**Department of the Navy
Naval Facilities Engineering Command, Hawaii
400 Marshall Road
JBPHH HI 96860-3139**

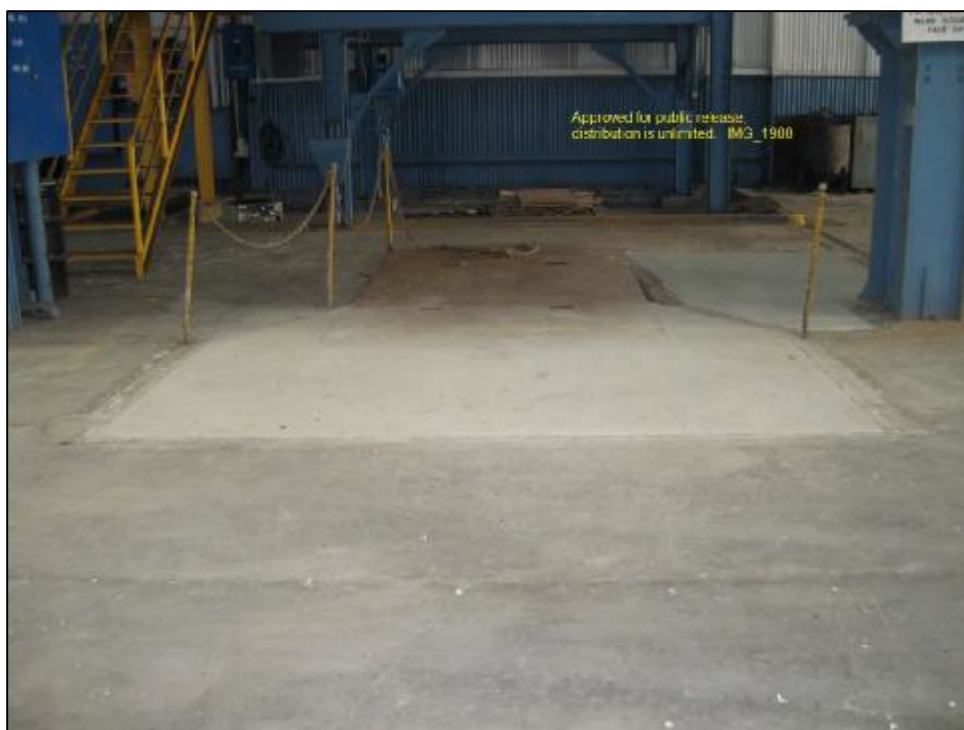
Photograph No. 4: View of vault within Bldg. 6 that was covered in concrete.
